# Use of a Small Unmanned Aircraft System for Autonomous Fire Spotting at the Great Dismal Swamp

**This paper describes the results of a set of experiments and analyses conducted to evaluate the capability of small unmanned aircraft systems (sUAS) to spot nascent fires in the Great Dismal Swamp (GDS) National Wildlife Refuge. This work is the result of a partnership between the National Aeronautics and Space Administration and the US Fish and Wildlife service specifically to investigate sUAS usage for fire-spotting. The objectives of the current effort were to: 1) Determine suitability and utility of low-cost Small Unmanned Aircraft Systems (sUAS) to detect nascent fires at GDS; 2) Identify and assess the necessary National Airspace System (NAS) integration issues; and 3) Provide information to GDS and the community on system requirements and concepts-of-operation (CONOPS) for conducting fire detection/support mission in the National Airspace and (4) Identify potential applications of intelligent autonomy that would enable or benefit this high-value mission. In addition, data on the ability of various low-cost sensors to detect smoke plumes and fire hot spots was generated during

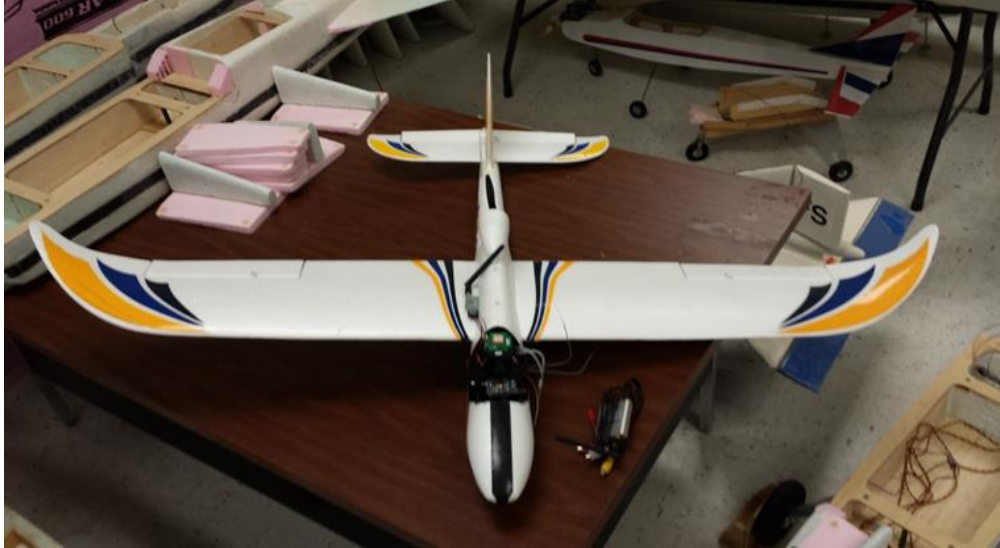
Figure 11 - Bixler COTS sUAS.

The Bixler UAS, sold by 3-D Robotics and shown in Figure 11, is representative of the class of small, hand-launched vehicles that are currently available in the US market. It weighs approximately 3.5lb. and

has a wingspan of less than 5ft. It uses the Ardupilot autopilot similar to what was installed in MigLH. It is equipped with a color daylight camera and video overlay. Flight tests with this platform initially had the same reliability issues as the same unit in MigLH. Subsequent upgrade of the autonav unit provided much better reliability, similar to what was seen with the MigLH. It was felt that whereas the MigLH requires a “runway” for takeoff and landing, the Bixler had more utility since it required far less of an operating area for launch and recovery due to being hand-launched and belly landing recovery. Flight speeds were much lower for the Bixler than those of the MigLH.

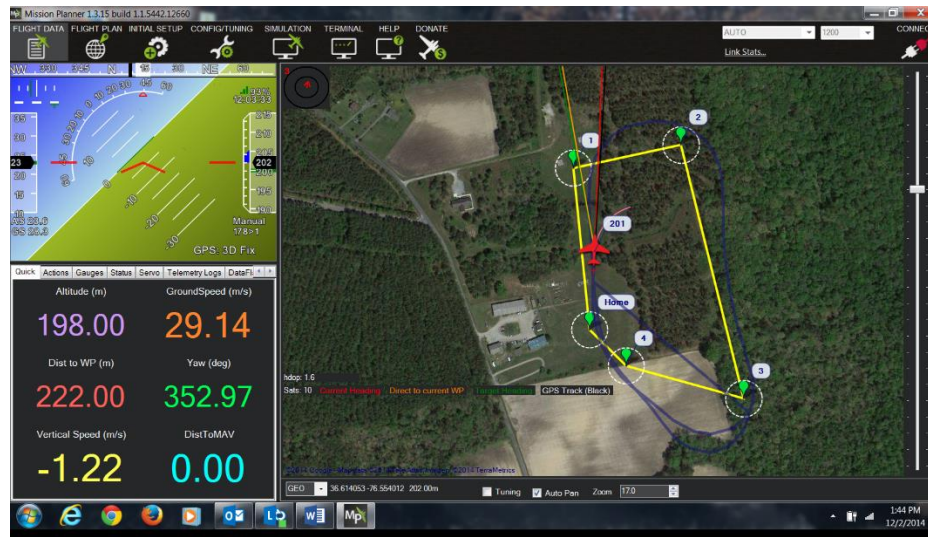
Figure 13 - Image from the Mission Planner software.

Mission Planner is provided in Figure 13. In Figure 13, it can be seen that Heads-Up-Display (HUD)-like aircraft airspeed, altitude, and other parameters are provided in the upper left of the Mission Planner display. A gods-eye-view map, showing waypoints, desired route, and aircraft location are shown on the right in Figure 13. Quick-view parameters including altitude, ground-speed, distance to next waypoint, heading, vertical speed, and distance to the home point are provided in the lower left of the Mission Planner display. The autopilot laptop was a commercially available ruggedized unit running Windows 7. The 4-G wireless hotspot was required to support

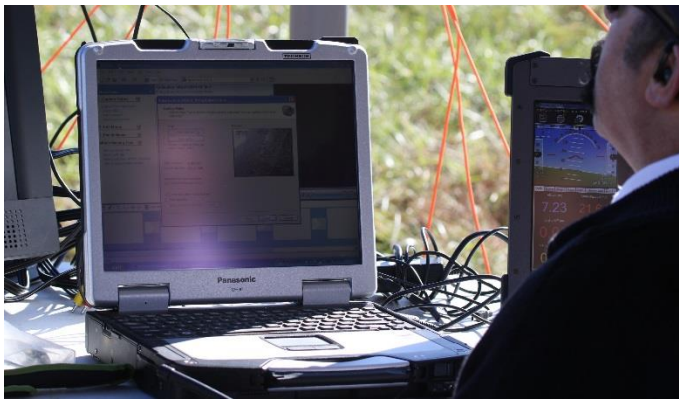
Figure 14 – Video control ground station.

downloading of the terrain maps for the APM software. Pre-loading the terrain maps was also an option for the APM software. The video recording laptop was a standard computer running Windows XP. Its function was to support configuration of the video telemetry system, monitoring the telemetered video during flight, and capturing and recording the video to the hard-drive for subsequent analysis. Figure 14 provides a photograph of video control portion of the ground station. The Autopilot datalink operated on the 900 MHz frequency band while the Video datalink operated on the 5.8 GHz band.

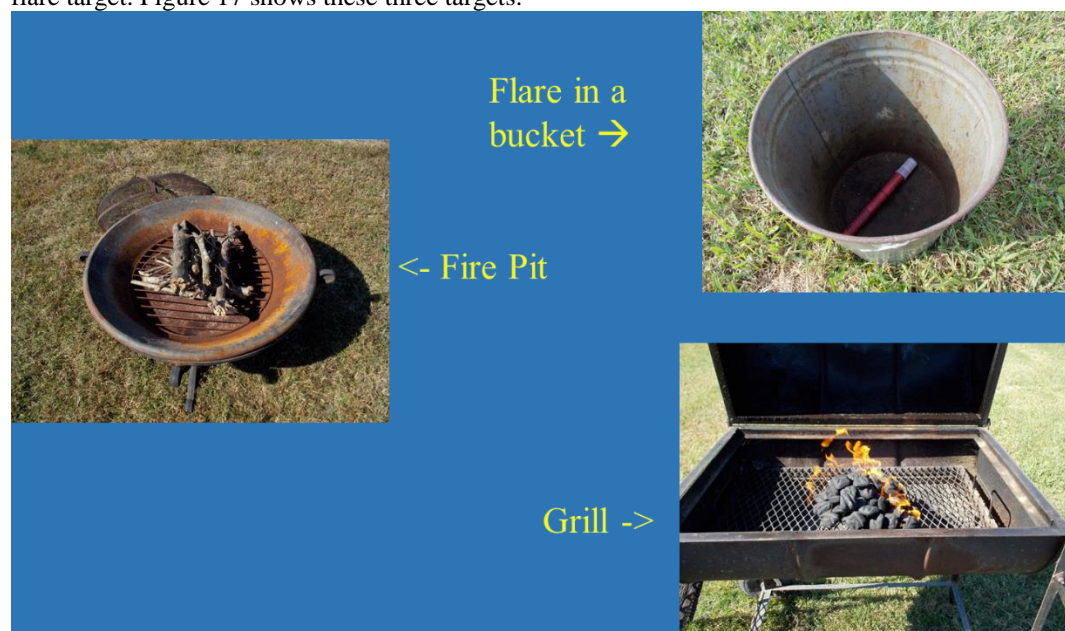
Figure 17 - Representative fire targets

In order to test the efficacy of the sensor suite and the platform to perform basic fire detection tasks, a series of flight tests were conducted using simulated targets of different types. First, a road flare was placed in a metal bucket and lit. This would represent an easy to implement, low cost method of providing a target with the hottest target temperature likely to be encountered (roughly 2000deg. F). Second, a fire pit approximately 3ft in diameter with indigenous organic material such as wood branches, leaves, pine needles and peat moss were used as representative of a “nascent” fire similar to what would be expected at GDS. Third, a typical steel grill was used with a charcoal fire and the lid closed to concentrate the plume and somewhat attenuate the temperature signature during the test. The fire pit and steel grill were implemented after the initial set of flights showed adequate detection of the road flare target. Figure 17 shows these three targets.

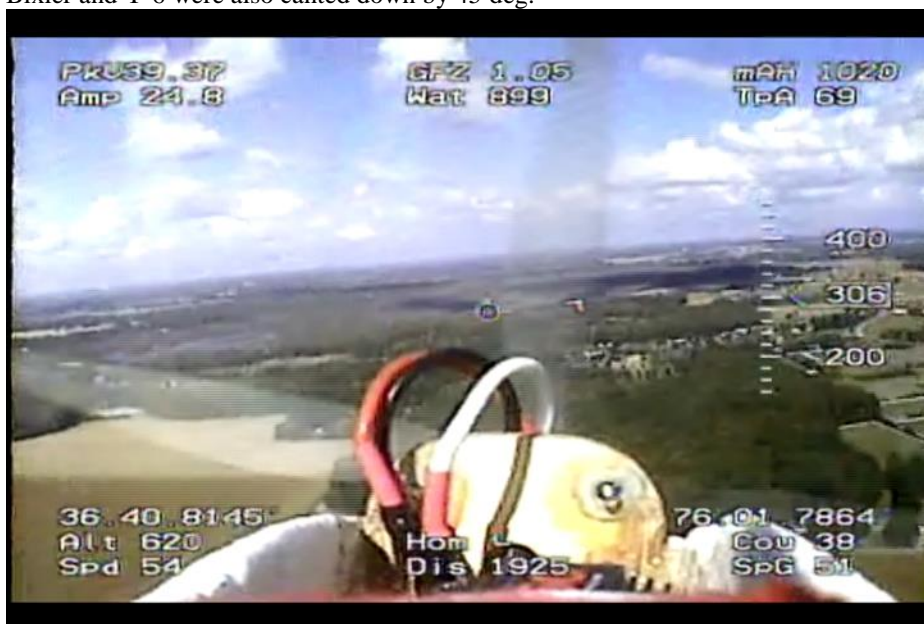
Figure 10 - MigLH forward facing camera image.

During the flights, neither the MigLH nor the Bixler's color daylight camera provided video watchers with sufficient imagery to visually detect smoke plumes. It was later determined this was largely due to the use of very open space to place the targets and the subsequent rapid wind dissipation of the plumes. In addition, it was determined that the forward facing cameras on all platforms needed to have a more downward cant, and in the case of the MigLH be relocated to the bottom of the aircraft, to provide better plume imagery. Note that for the initial MigLH flights, much of the downward portion of the image was obscured by the airframe itself (see Figure 20). As a result, the forward facing camera was moved to the bottom of the airframe and re-installed at a 45deg. cant downward. Cameras on the Bixler and Y-6 were also canted down by 45 deg.

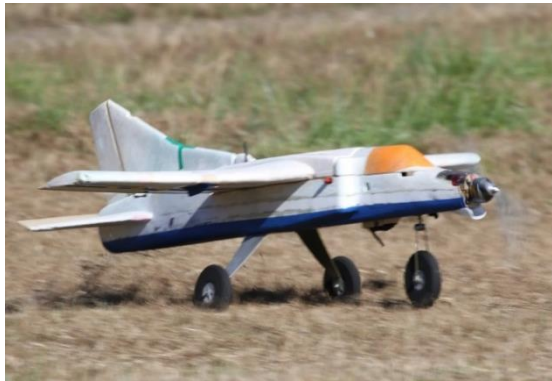
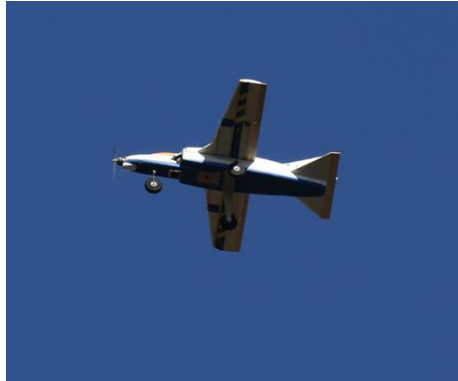
Figures 26 and 27 provide photographs of the MigLH during operations at the Great Dismal Swamp Fire Station location. An approximately 550 ft long by 50 ft wide grass runway was mowed into a field behind the Great Dismal Swamp Fire Station. This resulted in a runway which was only somewhat rough. However, as part of the changes made during the initial research flights, larger tires had been installed on the landing gear providing better propeller ground clearance and rough field performance. Takeoff field length over a 10ft. obstacle was approximately 200ft, while landing over a 10ft. obstacle required approximately 500ft.

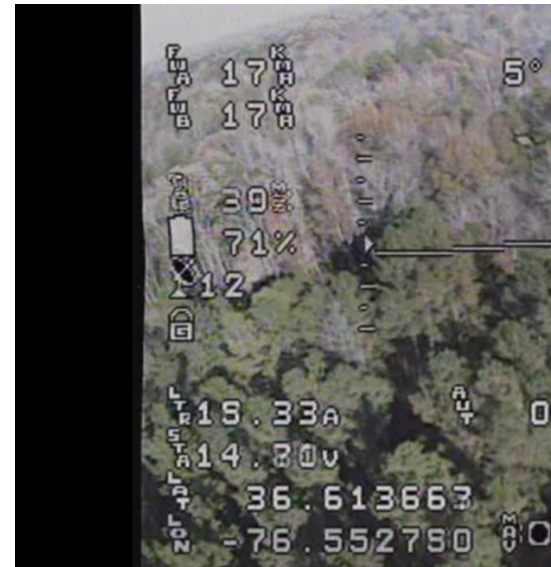
Figure 29 - Imagery from Y-6 at GDS.

The Y-6 was flown twice, once in manual mode, once in full auto mode where the vehicle took off, navigated through its mission waypoint set, and landed autonomously. Figure 28 shows the Y-6 in flight with Figure 29 an extract from the Y-6 video downlinked.

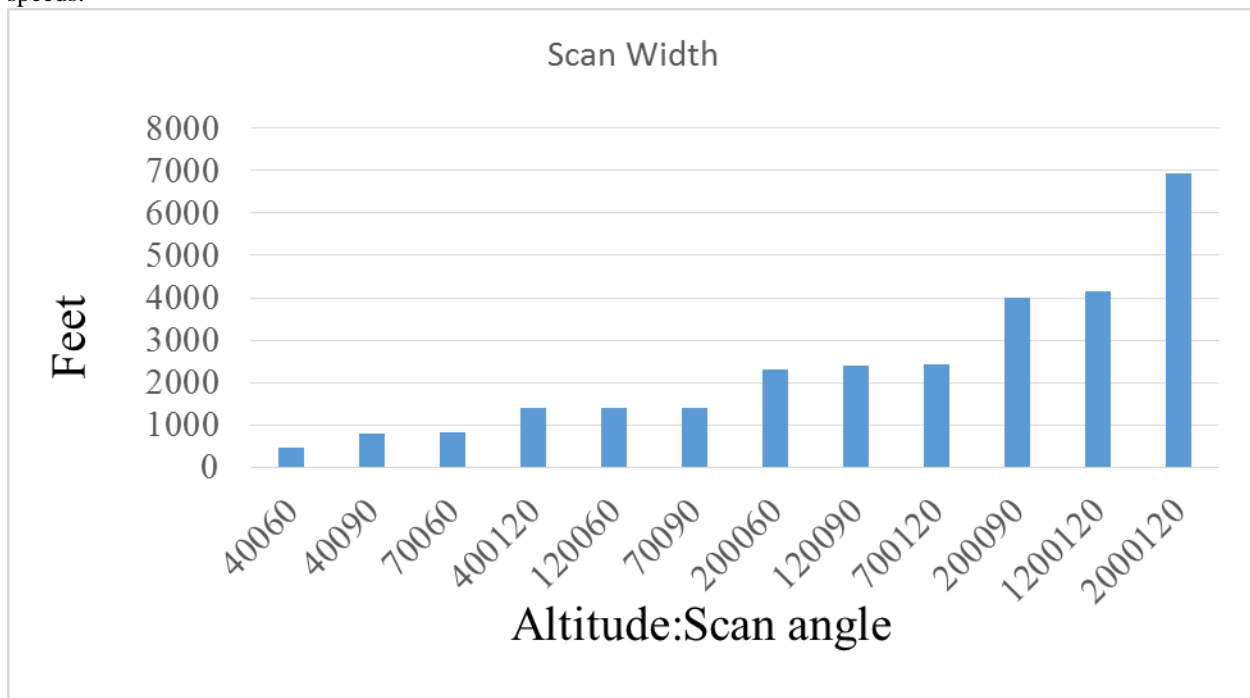
Figure 30 Ground scan width for a combination of altitude and sensor FOV.

For this analysis, altitudes of 400, 700, 1200, and 2000 feet were evaluated. These altitudes correspond to the lowest, most restrictive, maximum altitude for UAS operations (400 ft, 122m), the upper limit of Class-G airspace over the northern portion of the GDS (700 ft, 213m), the upper limit of Class-G airspace of the southern portion of the GDS (1,200ft, 366m), and the altitude that GA aircraft need to stay at or above while flying over the GDS (2,000ft, 610m) because of its status as a National Wildlife Refuge. Figure 30 illustrates the scan width for combinations of altitudes (400, 700, 1200, and 2000) and scan angles (60, 90, 120) for a downward-looking camera. Note in Figure 31 that the labels for the abscissa are concatenations of the scan altitude and scan angle. The results are sorted from lowest to greatest. From Figure 30, it can be seen that the effective scan widths range from as low as approximately 500 feet for the 400 ft scan altitude with 60 deg scan angle up to almost 7,000 ft for the 2,000 ft scan altitude with 120 scan angle. It can also be seen in Figure 31 that results were similar for different combinations of altitude and scan angle. For example, the results for the 700 ft and 120 deg scan angle were nearly the same as the 1,200 ft, 90 deg, and 2,000 ft, 60 deg combinations. While the similar scan widths can be achieved for these three combinations of scan altitude and scan angle, the primary difference would be the size of the camera pixel on the ground. Higher resolution cameras would likely be needed for higher altitude fire-spotting. Figure 32 illustrates the time required to scan the GDS for the series of altitudes and sensor scan angles described above for speeds from as slow as 20 mph up to 120 mph. The time required to perform the 180 deg turn to start the next scan is not included. The resulting time only indicates actual flight time and does include pre-flight or other preparation time. What can be seen from Figure 32 is that the 400ft scanning altitude meets an assumed 8-hr requirement only for scan angles of 120 degrees and speeds greater than ~95 mph. This speed may not be achievable for a low-cost UAS. Results for the 700 ft scanning altitude are better with both the 90- and 120-degree scan angles being feasible. Speeds as slow as ~55 mph could scan the entire GDS with a 120 deg HFOV at 700 ft. Increasing the scan altitude to 1,200 and increasing the scan angle to 120 degrees would be required to enable slower, more efficient, scan speeds of ~35 mph. The 2,000 ft scanning altitude would enable use of narrow field of view cameras and/or slower scanning speeds.
